Eastview Neighborhood Waste Collections Operational Assessment

Photo Log: Eastview Neighbourhood

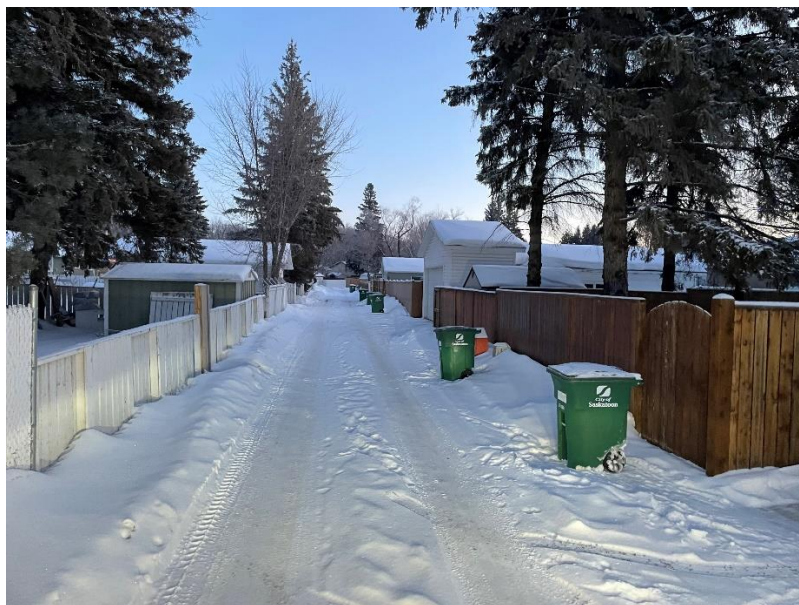
Photo 1: Green Cart Collection

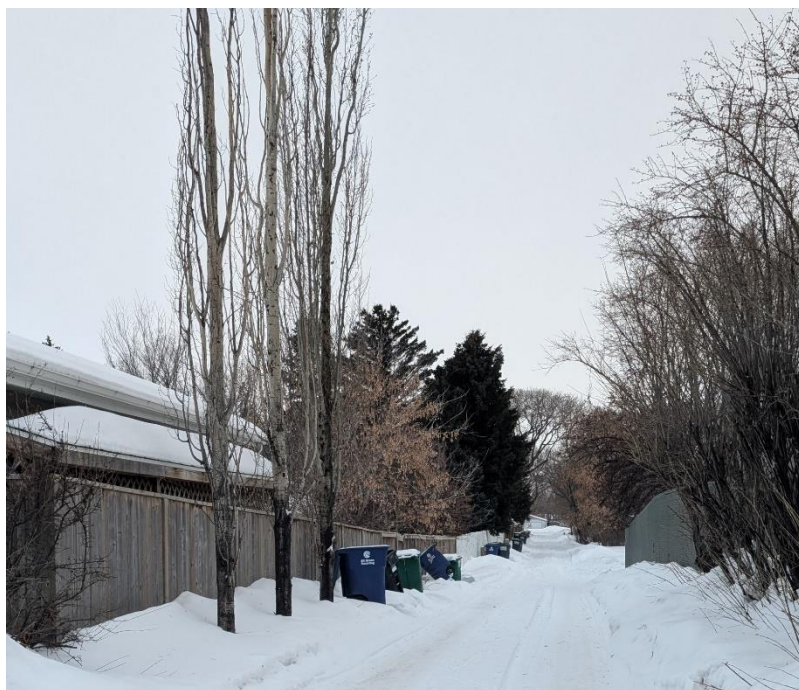
Photo 2: Black Cart Collection

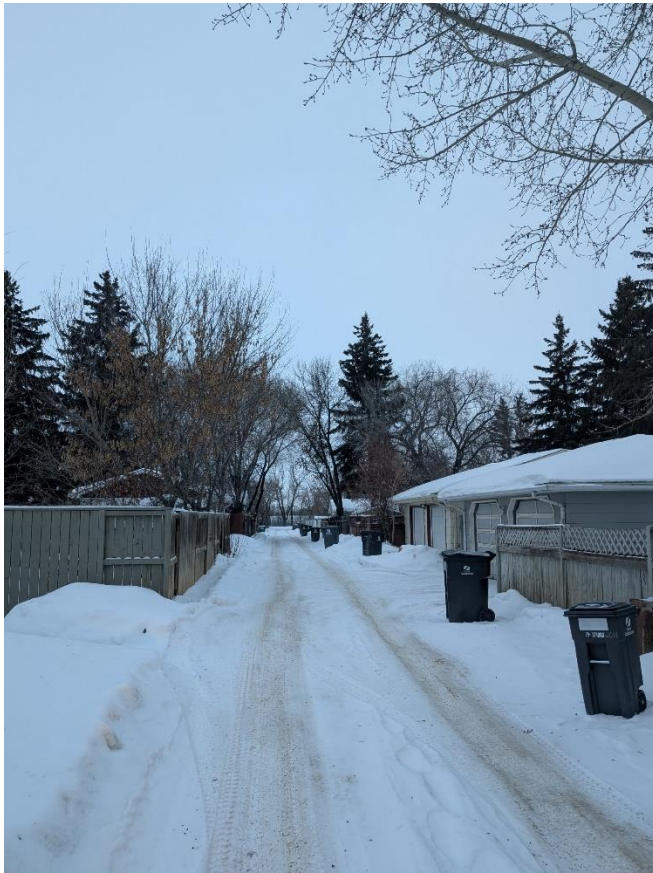
Photo 4: Black Cart Collection

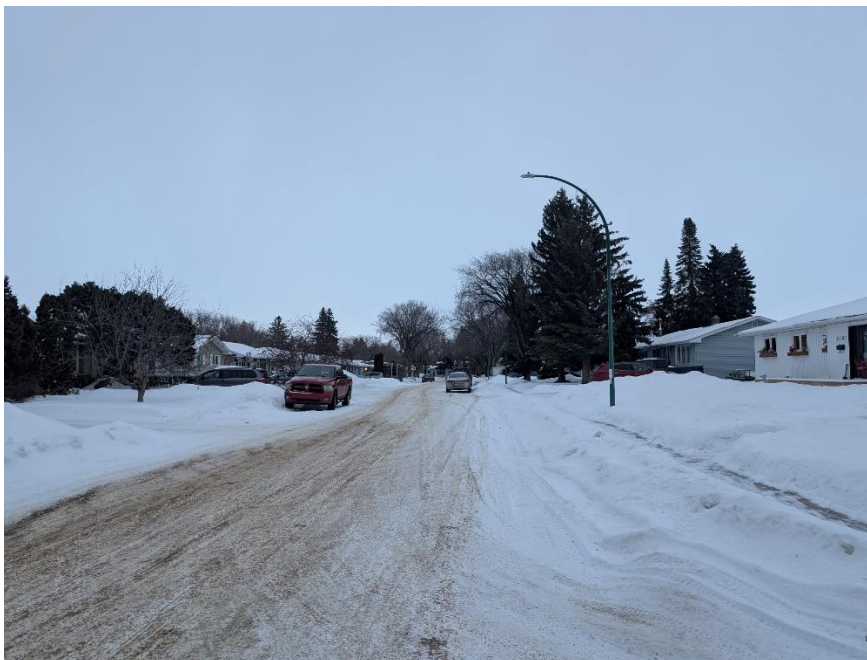
Photo 3: Front Street

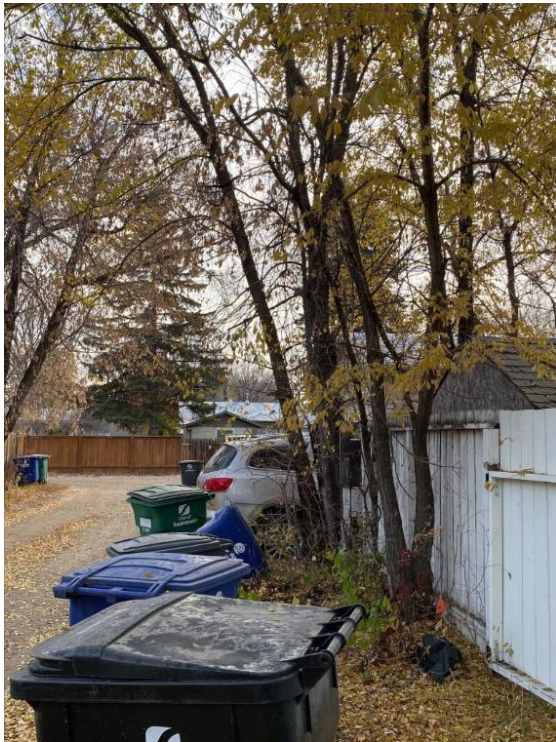
The Waste Bylaw includes provisions for the placement and storage. As outlined in, Section 13 waste containers must be returned to private property by 7:00 p.m. on collection day and cannot remain on the public-right-way. EPO's complete education and enforcement initiatives and will review neighbourhoods for carts that are left out. The process involves sending block-wide education letters to areas where many carts were left outside their scheduled collection window. The education letters are followed up with a re-inspection of the identified locations. Warning letters are issued to any properties that continue to leave carts out. A final re-inspection is completed and if required a notice of violation issued. An enforcement blitz of the Eastview neighbourhood was completed in the Spring of 2017 with the information from the activity included below.

Photo 3: Carts Left Out

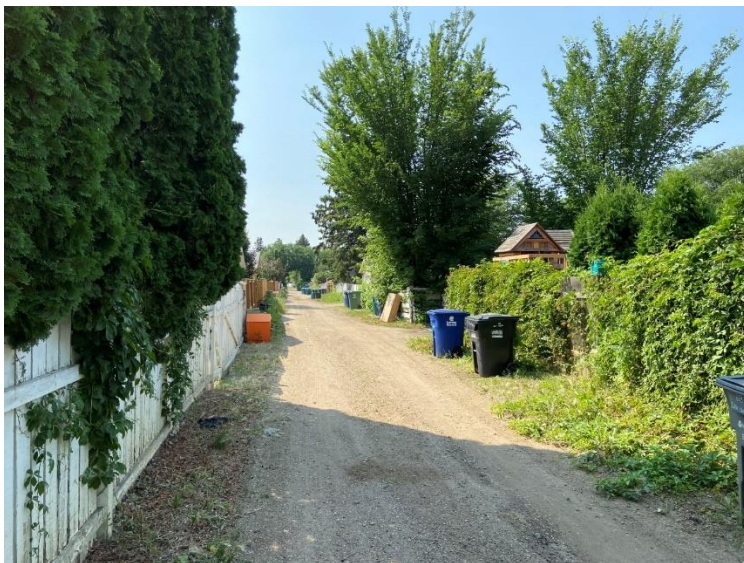
Photo 5: Carts Left Out
