## Damaged Foundation Photographs (Excerpt of Engineer's Report)

### Heritage Conservation Program – 518 11<sup>th</sup> St. E. – Work to Restore Structural Integrity

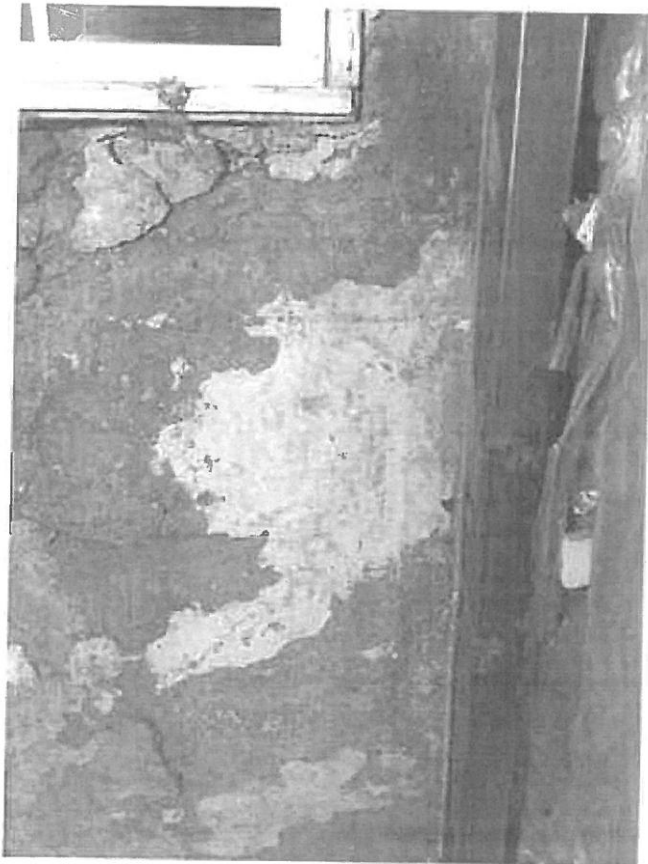
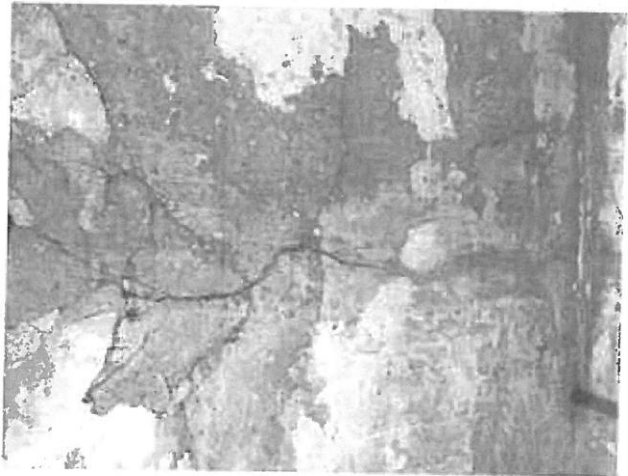
As detailed on the attached engineer's report, the work to be undertaken is required to repair the basement "that is cracked and has been forced inward." The reinforcement includes:

Sample photographs of the damaged foundation are included below.

- Building a structural wall of 2x8 ACQ unincised pressure treated wood
- Sealing cracks with a mastic sealant and further sealed with concrete/polyethylene
- Installation of a sump pump to remove any water that may still penetrate the basement and cause further foundation problems
