## Examples of Work Zones

The following are examples of past work zones that illustrate both good and bad examples of pedestrian and cyclist accommodation in work zones. Each example discusses the pros and cons of the work zone and highlights where improvements could be made to make the accommodations safer and more convenient for active users.

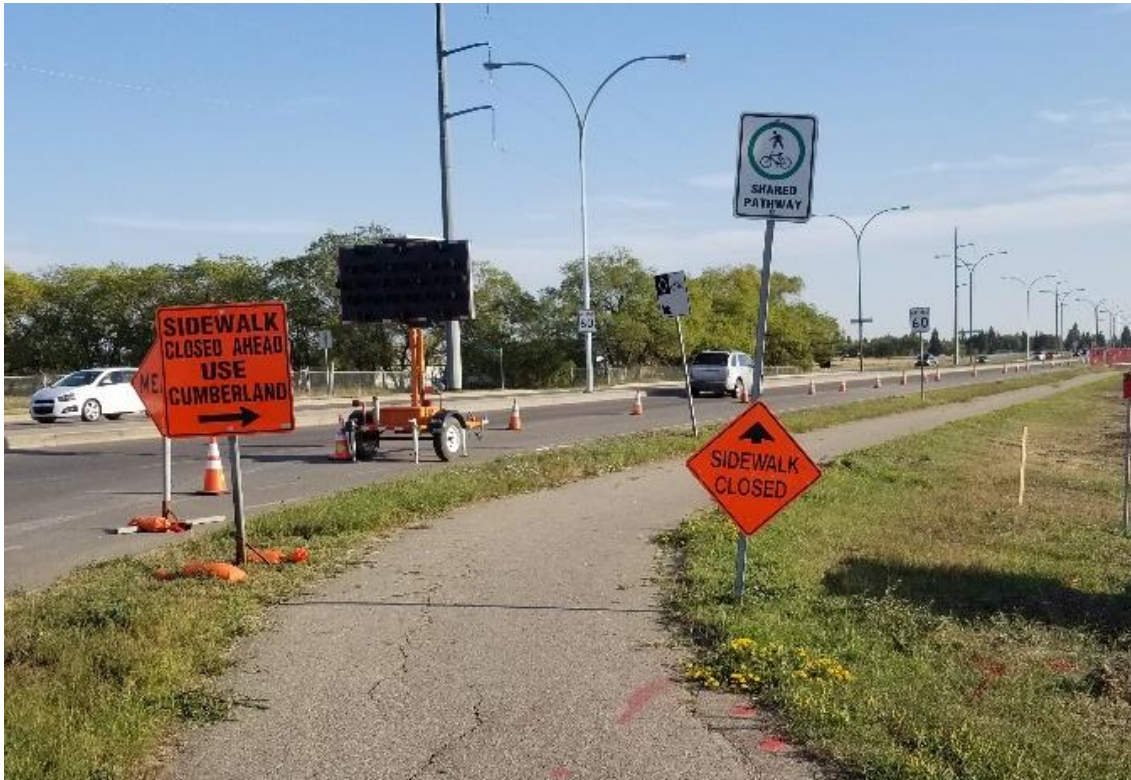
Image 1: Multi-use pathway closure signs at Preston Avenue and College Drive

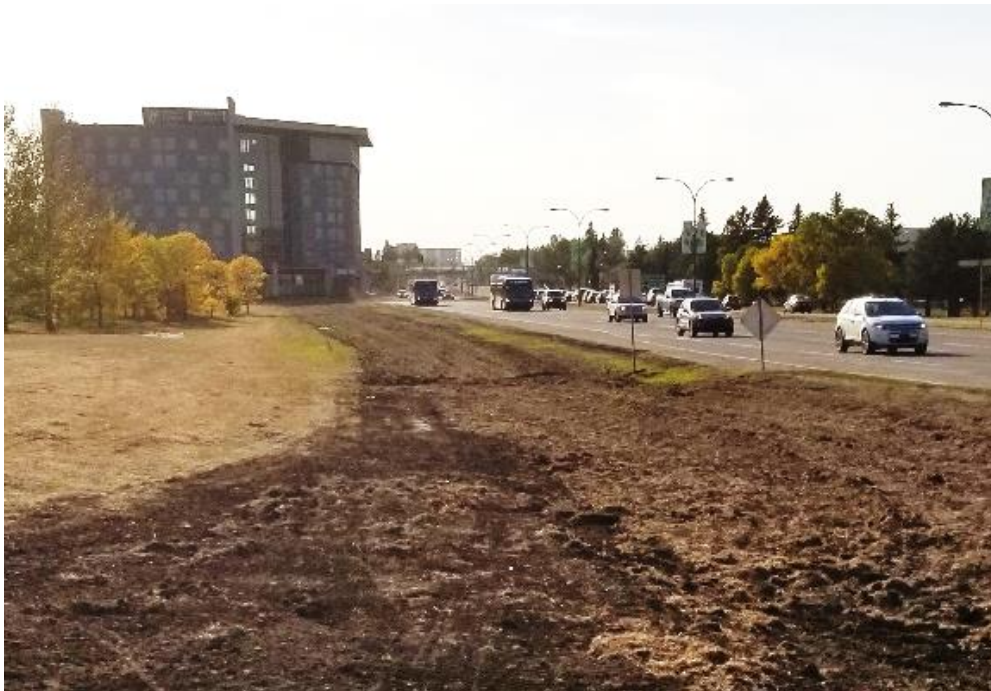
The guidance provided at the closure directed pedestrians and cyclists approaching from the north to use Cumberland Avenue, but no facility was available along College Drive to facilitate this movement. Further, no information regarding the distance of the detour was provided nor was advance signage placed to advise pedestrians and cyclists to choose an alternate route.

Image 2: Recommended pedestrian and cyclist detour route at Preston Avenue and College Drive

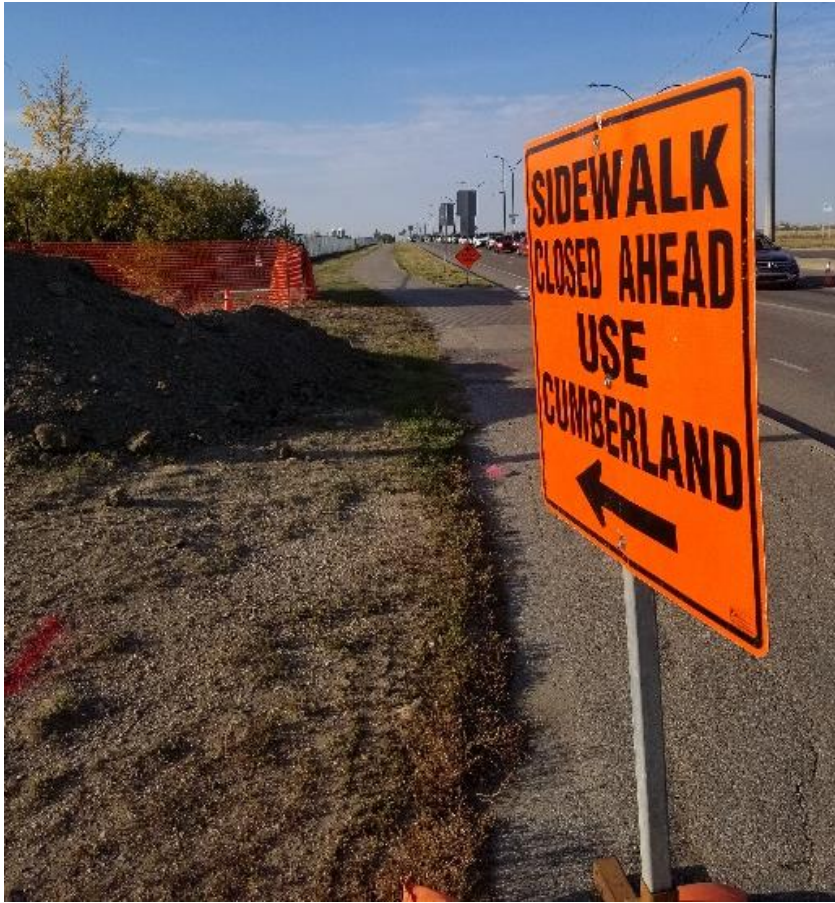
On the south end of the work zone there was an advanced sign, but its orientation was only to users proceeding east. Users travelling west intending to proceed northbound on Preston Avenue would not see the signs.

Image 3: Poor orientation of detour sign at Preston Avenue and 14<sup>th</sup> Street

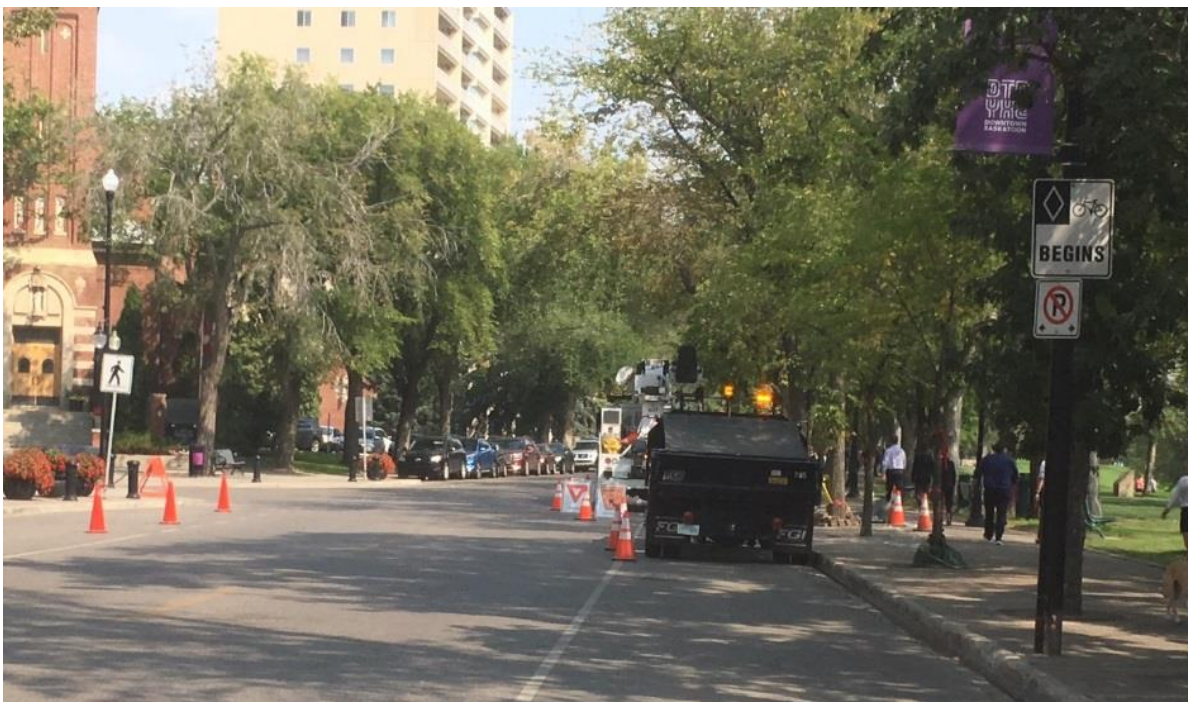
This example involves a short duration temporary closure of the bicycle lane along Spadina Crescent. To complete minor repairs, temporary closures or diversions may be required for short periods of time. It is important that the needs of pedestrians and cyclists are taken into consideration in these types of closures as well. In this particular instance, the temporary traffic control was improperly implemented. Signs were placed too close together, there was a lack of taper to direct traffic, and guidance was not provided to cyclists to indicate that the bike lane was closed, and that cyclists and motorists must share the traffic lane. The addition of signs communicating the closure of the bike lane and expected travel behaviour for both vehicles and cyclists would improve the safety of all road users in this type of temporary traffic control.

Image 4: Lack of signage directing cyclists and vehicles to share the traffic lane

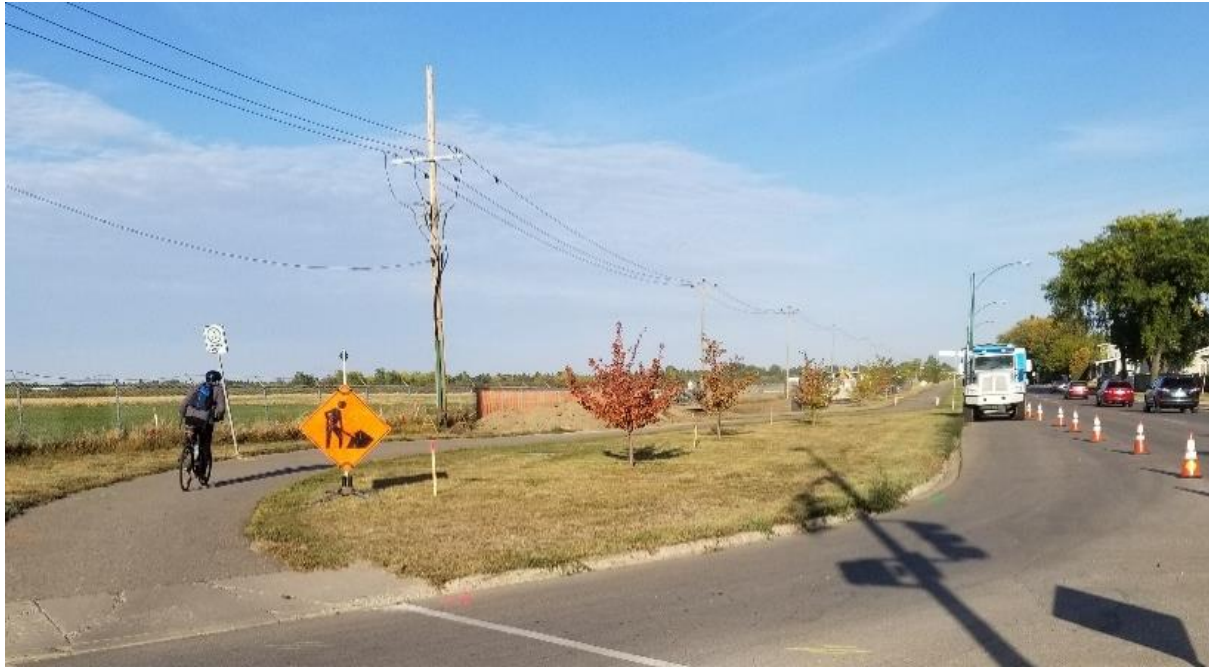
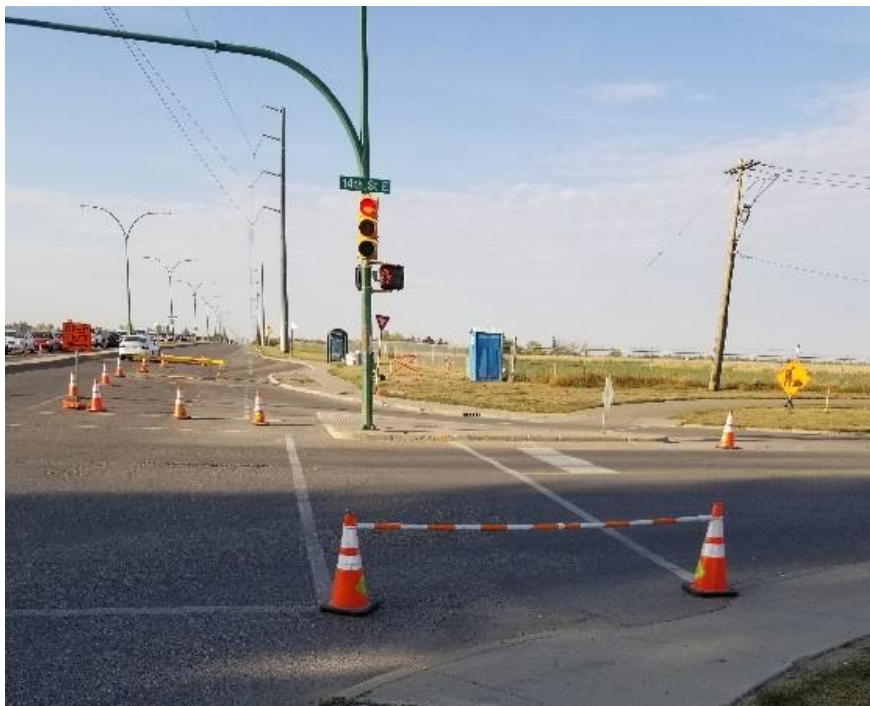
This detour is an example where a third-party was doing work adjacent to the multi-use pathway along 14<sup>th</sup> Street. The work zone lacked signage indicating that the area is restricted and there was no guidance directing cyclists and pedestrians to an alternative route.

Image 5 and 6: Lack of signage indicating the pathway is closed

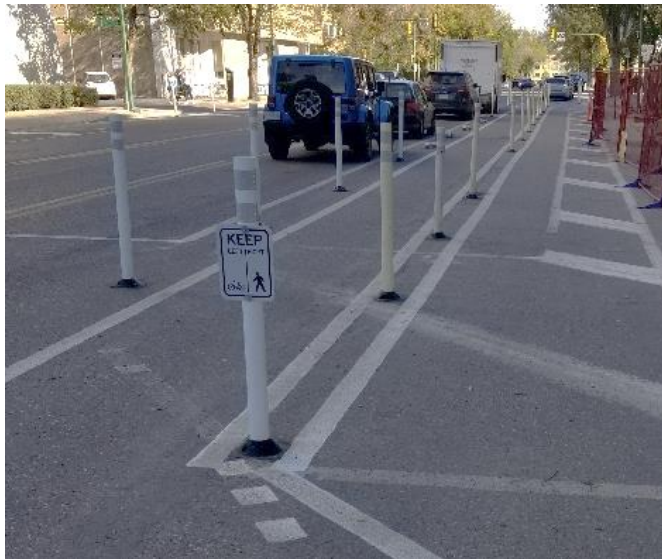
The diversion previously in place in front of the former Police Station on 4<sup>th</sup> Avenue is a good example of a work zone accommodation for pedestrians, cyclists and vehicles that meets the intent of the proposed policy. This diversion respected the needs of all road users by replicating, as nearly as is practicable, the facilities that the work zone is disrupting. Further improvements to this diversion would include better accommodations for people with low vision or mobility limitations, such as a straight, detectable edge for people with visual impairments and ramps for people using mobility aids. Further, the protected bike lane is fully retained. This diversion is good example of how to provide safe, convenient temporary facilities for pedestrian and cyclists.

Image 7: Human-scaled signage indicating the spaces for pedestrians and cyclists

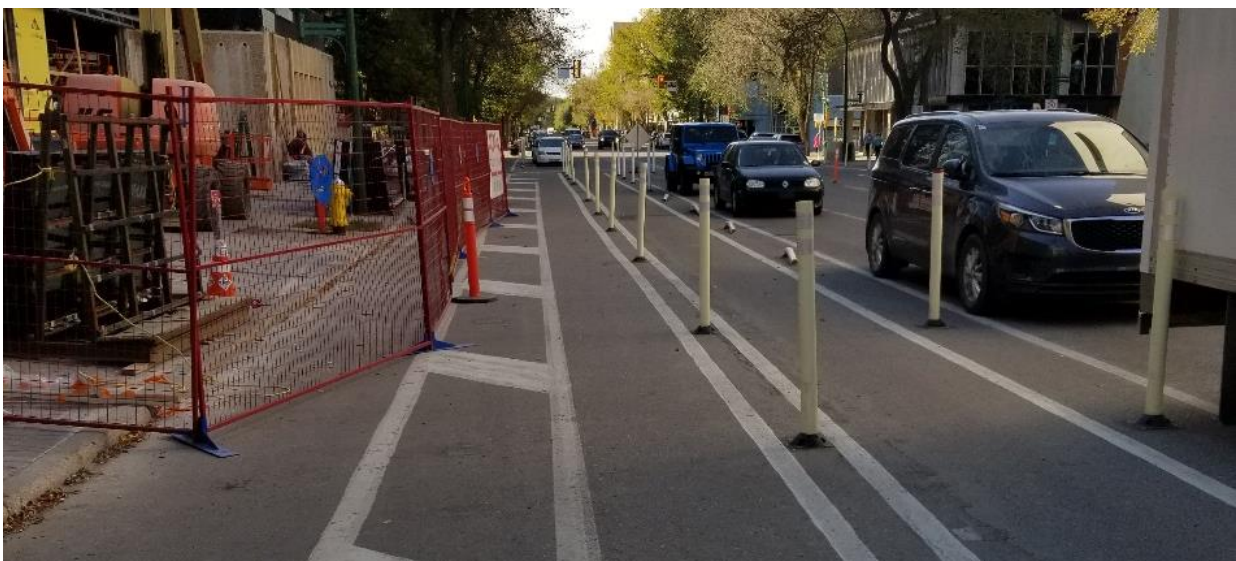
Image 8: Providing a straight, cane detectable edge would improve this diversion for people with visual impairments

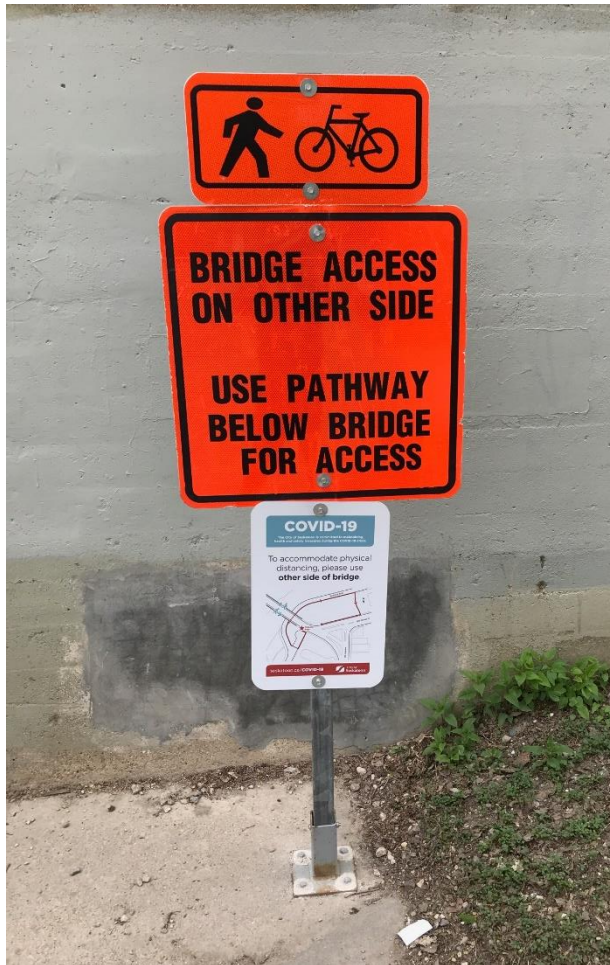
To support physical distancing requirements during the COVID-19 pandemic, one-way travel restrictions were put in place on bridge pathways where two metre physical distancing could not be achieved. These signs were oriented toward pedestrians and cyclists and provided information to bridge users through advanced warning signs, access points, and directions to the alternative routes. The signs utilized for these travel restrictions are a good example of providing pedestrians and cyclists with the information needed to make timely decisions about their route.

Image 9: Example of sign oriented toward pedestrians and cyclists.

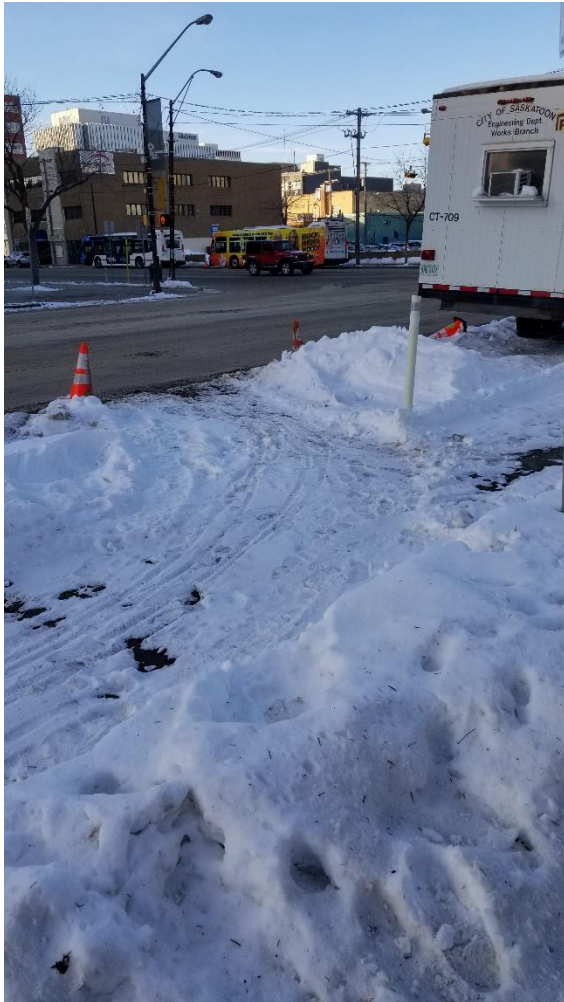
In November 2020, a crew trailer was placed at the corner of 23rd Street and 3rd Avenue for City staff to use during the initial response to the COVID-19 pandemic. This trailer was installed without adequate signage and detour markings. As shown in the photos below, the bike lane was blocked off without any signs being provided to indicate that the lane was blocked or providing guidance to motorists or cyclists on what behaviour was expected through this construction zone. The lack of guidance has resulted in people riding in the bike lane “merging” with traffic just prior to the trailer, creating hazardous conditions for both motorists and cyclists.

Image 11: protected bike lane ends without guidance to cyclists or drivers

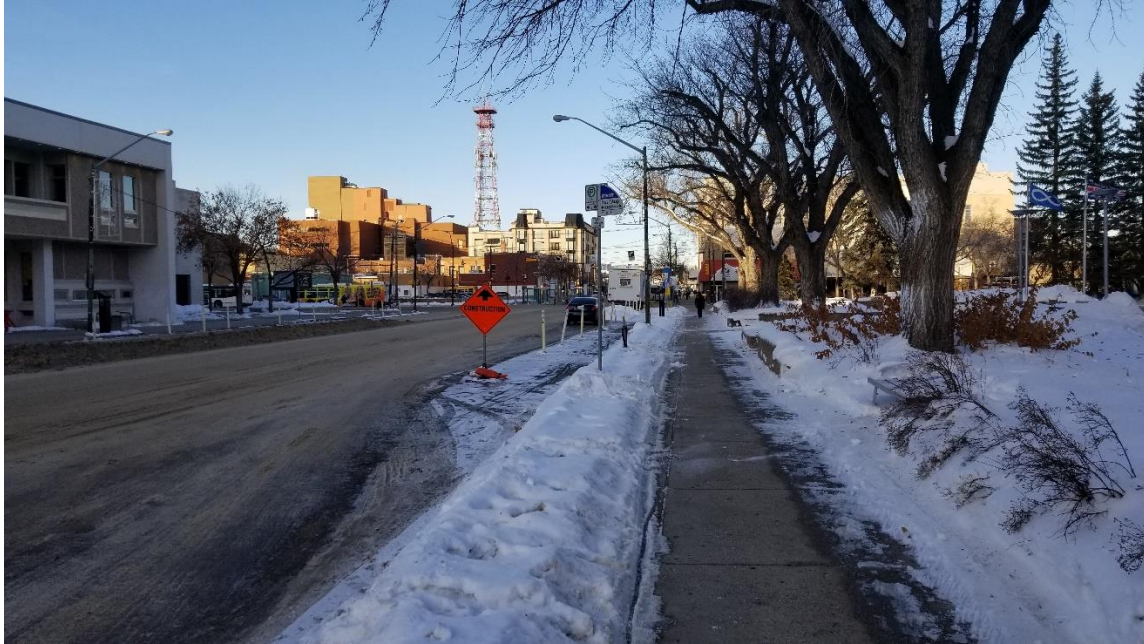
Image 12: Lack of signs indicating appropriate direction for cyclists or motorists
