Photographs of McOrmond Drive Multi-Way Boulevard

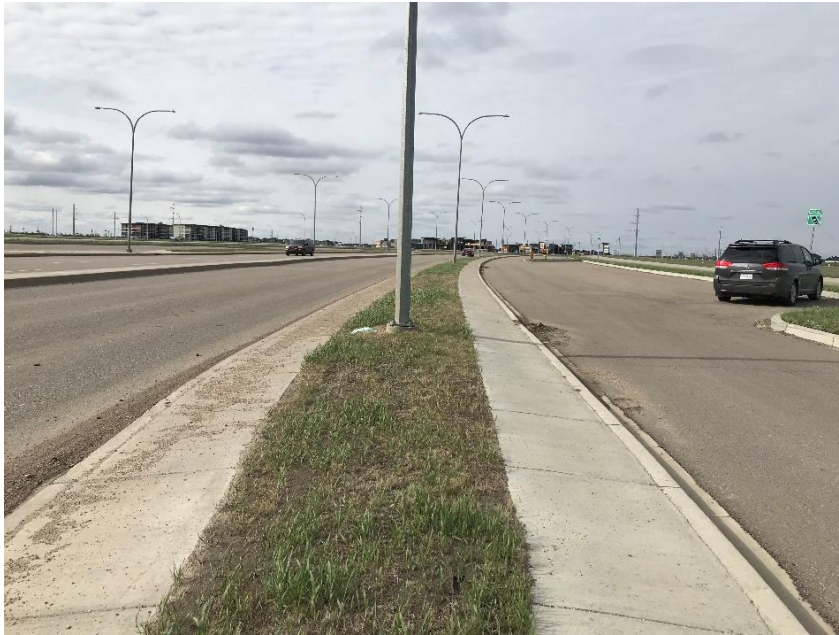
The 4.0 m boulevard space in Figure 11 is used to store snow graded from the through lanes of McOrmond Drive. The 1.5 m concrete median in Figure 22, separating the opposing directions of travel on McOrmond Drive, is too narrow to accommodate snow from four through lanes as well as turning lanes on McOrmond Drive.

*Figure 1: McOrmond Dr. south of Feheregyhazi Blvd. Looking south at the 4.0 m boulevard between the through lanes and access lane/angled parking.*

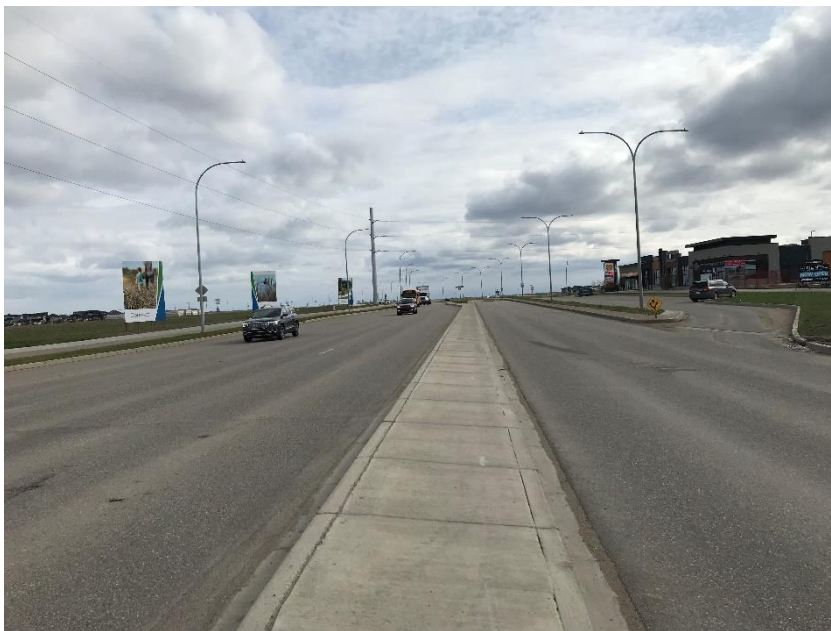
*Figure 2: McOrmond Dr. north of Fedoruk Rd. Looking north at the median separating direction of travel.*

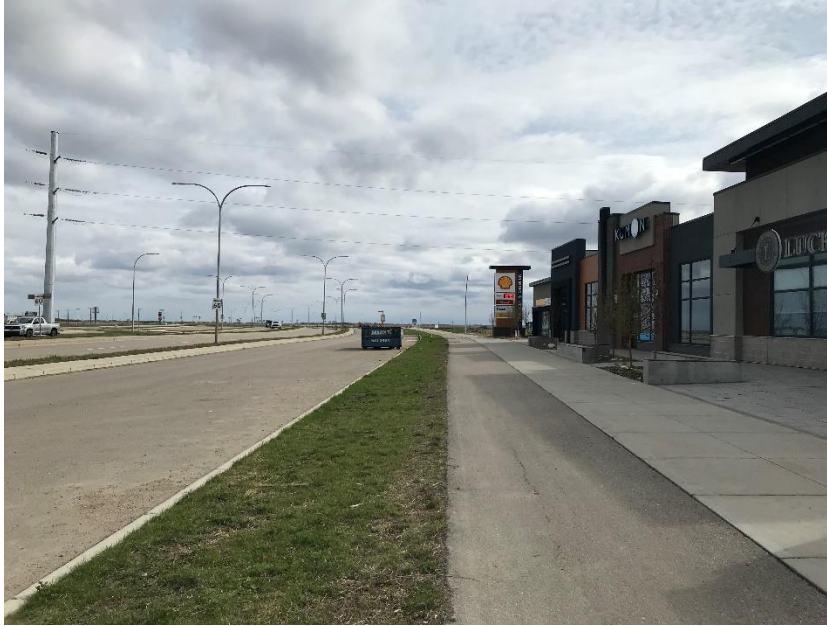
The Functional Plan from 2016 indicated the boulevard (grass landscape strip) between the angled parking and sidewalk could be used for snow storage. Snow storage on the boulevard creates a slip/trip/fall safety hazard. Pedestrians are not able to safely access their parked vehicles.

*Figure 3: East side of McOrmond Dr. north of Fedoruk Dr. Looking north at the boulevard at Evergreen Crossing. 2.0 m boulevard (grass landscape strip) with 2.0 m asphalt cycle track and 2.5 m concrete walkway.*

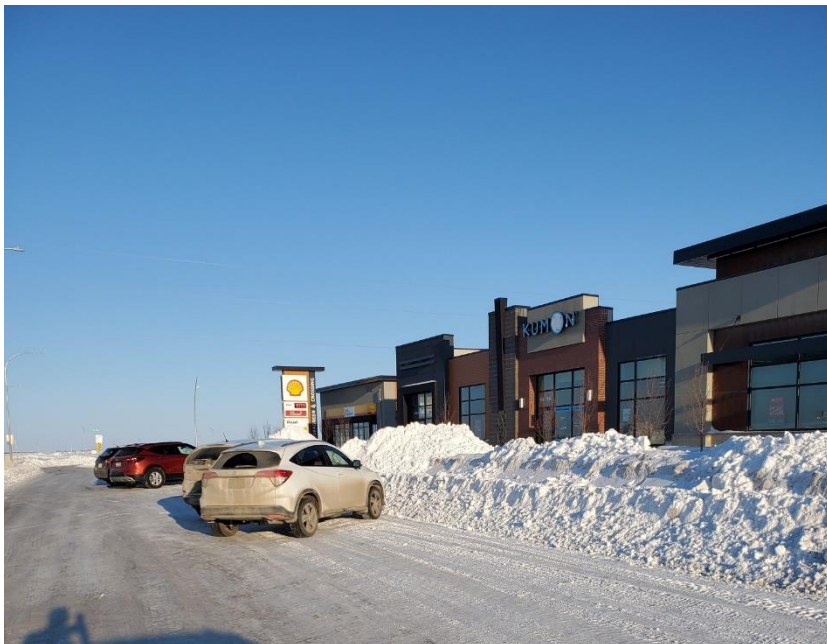
*Figure 4: Winter 2021-2022. Snow windrowed on the boulevard (grass landscape strip), blocking access between sidewalk and parked vehicles.*
