Building Better Parks: An Asset Management Plan for Parks

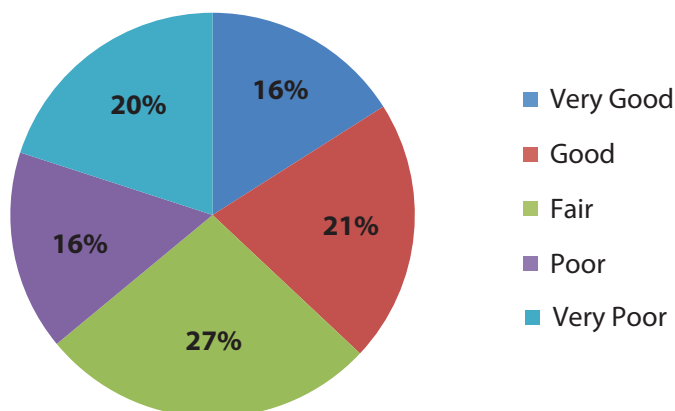
% of Total Asset Replacement Cost in each Category

The chart below illustrates the % of total assets based on replacement value that falls under each condition rating. Overall, the majority of park assets, or 64%, are rated fair or above condition with 16% being close to the end of their life and 20% identified as being past their useful life.

Although 64% of park assets are in fair or better condition, this is largely due to the fact that a substantial amount of park space has been developed over the past 10 years as Saskatoon experienced significant growth. This means assets are in good or very good condition as they are relatively new, however, moving forward the City has very little funding dedicated towards the rehabilitation and replacement of parks assets, approximately \$960,000 per year. As this growth of park infrastructure continues, it will be important to ensure that appropriate amounts of operating funding are applied to the various park assets so that expected asset life cycles and desired asset conditions can be achieved and sustained.
